# Performance of a Polyurethane Core Seal Tested in a Hydrostatic Chamber

**Report of Investigations 9674**

**By Dennis R. Dolinar, Michael J. Sapko, and Samuel P. Harteis**

May 2008

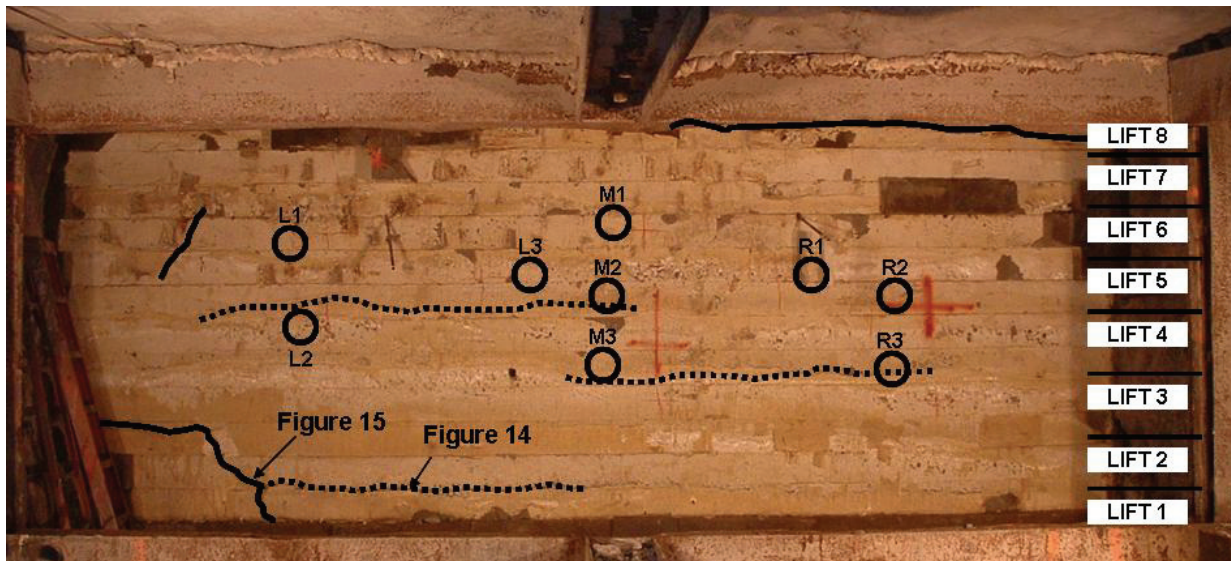
To evaluate the damage done to the polyurethane seal core, the front stack wall was removed. Figure 13 shows the seal after removing the block wall, with the fractures and open joints indicated. Fractures developed at or near the lift joints at the lower left and upper right side of the seal. There is also a fracture cutting across the lifts along the lower left side of the seal. The joints along the lifts near the center portion of the seal also opened. Figure 14 shows the major fracture or open joint that formed parallel to the lifts just above the bottom row of blocks along the interface of lifts 1 and 2. Further, the area at and below the fracture parallel to the lift line was displaced a few inches horizontally over the top of the lowest row of block. Figure 15 shows the major fracture that developed across lifts 1 and 2 on the lower left side of the seal. This fracture was open along the front side of the seal core. A portion of the polyurethane was excavated so that internal damage to the seal and the back block wall could be examined. Internal damage to the seal near the floor is shown in Figure 16. The damage includes major near-vertical fractures in the lowest lift. This area is just to the right of the external fracture shown in Figure 15. Essentially, the external damage is directly related to the development and movement along these internal fractures. Even though there were several inches of horizontal displacement of the polyurethane core over the top of the first row of blocks in this area, no horizontal shear surface or fracture was observed at this location. A small diagonal fracture was also noted in the upper left quadrant of the seal (Figure 13).

Another zone of damage and deformation occurred near the roof and extends across most of the right side of the seal (Figure 13). In exposed portions of this damaged zone, there is high concentration of aggregate with very little polyurethane to lift the aggregate and to act as a binder (Figure 17). The seal below the fractured zone was displaced outward.

Other fractures opened along the joined surfaces between the top and bottom of the lifts (Figure 13). This occurred in the lifts from the upper middle portion of the seal and below and involved the interfaces between lifts 1 to 5. Cores taken along some of these joint surfaces reveal that the joint is open only to the middle of the seal, thus being restricted to the tension side of the seal (Figure 18).

Figure 13.—Damage observed in polyurethane core after removing block form. Fractures in seal are indicated with solid lines; open joints along lifts are indicated with dashed lines. Circles denote where core was obtained for compressive tests.

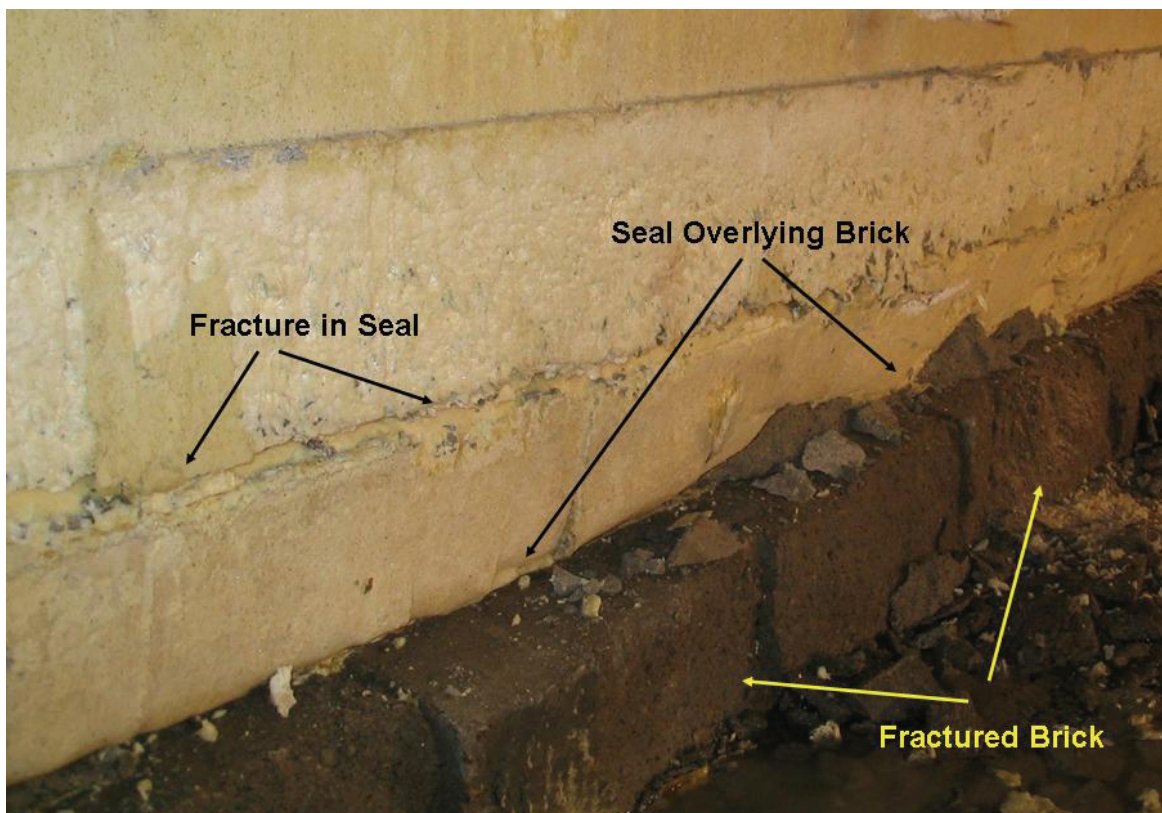
Figure 14.—Closer view of damage observed along lower left side of polyurethane seal along top of bottom row of blocks. Seal has displaced about 2 in over the top of the blocks. The fracture or open joint is along the interface of lifts 1 and 2.

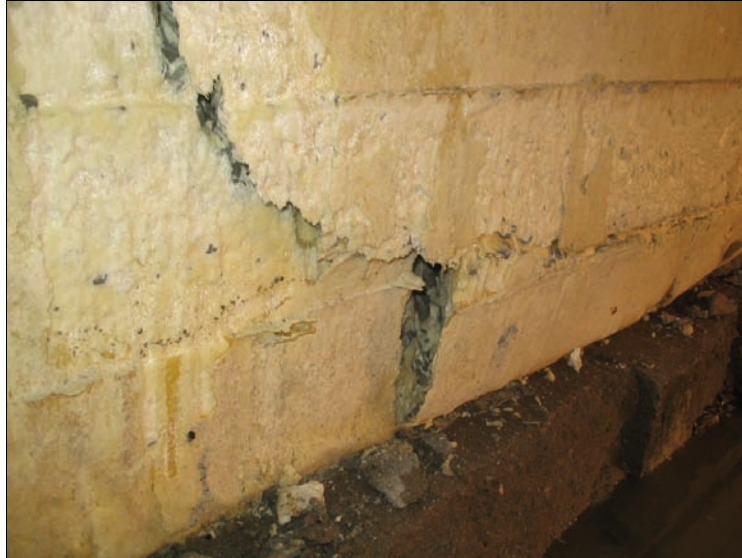
**Figure 15.—Fracture and damage observed along lower left side of polyurethane seal along top of bottom row of blocks.**

After the seal had failed structurally, the water flow rate was increased to 750 gpm and there was a subsequent increase in pressure to 14.5 psi. However, the seal could not sustain this added pressure, resulting in a large increase in deformation and a sharp drop in pressure to less than 8 psi. At this point, the fracture through the seal on the lower left side would probably have been fully developed (Figure 15).

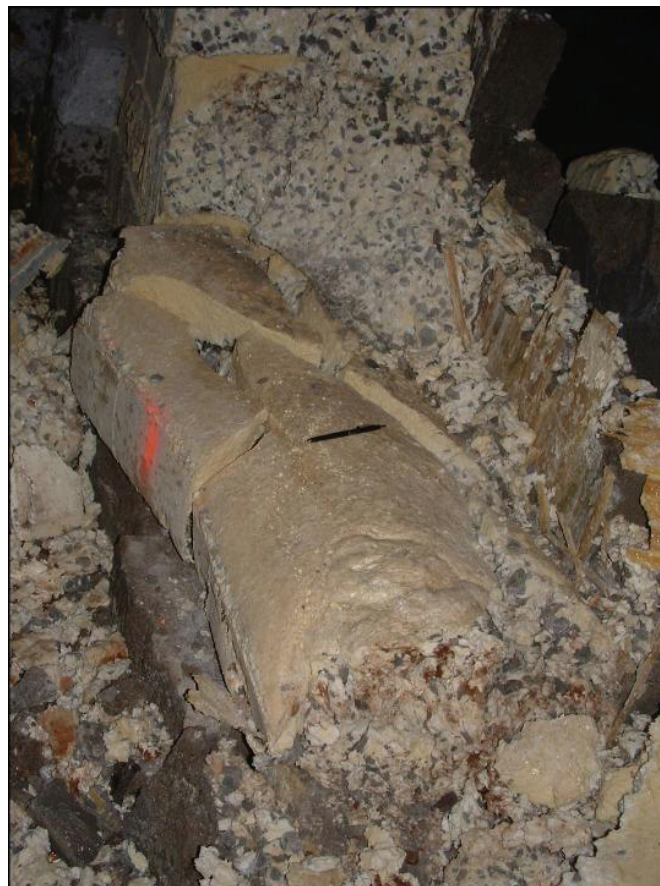
**Figure 16.—Internal damage along lower left side of polyurethane seal just above of the bottom row of blocks.**

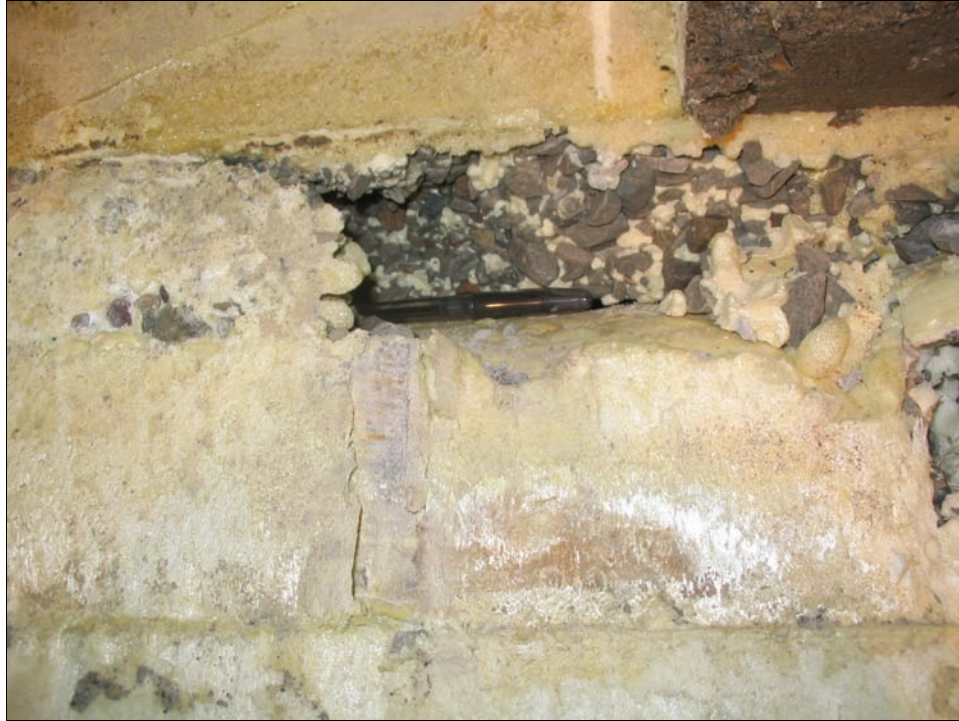
**Figure 17.—High concentration of aggregate that is poorly bonded with polyurethane observed along upper right side of seal.**

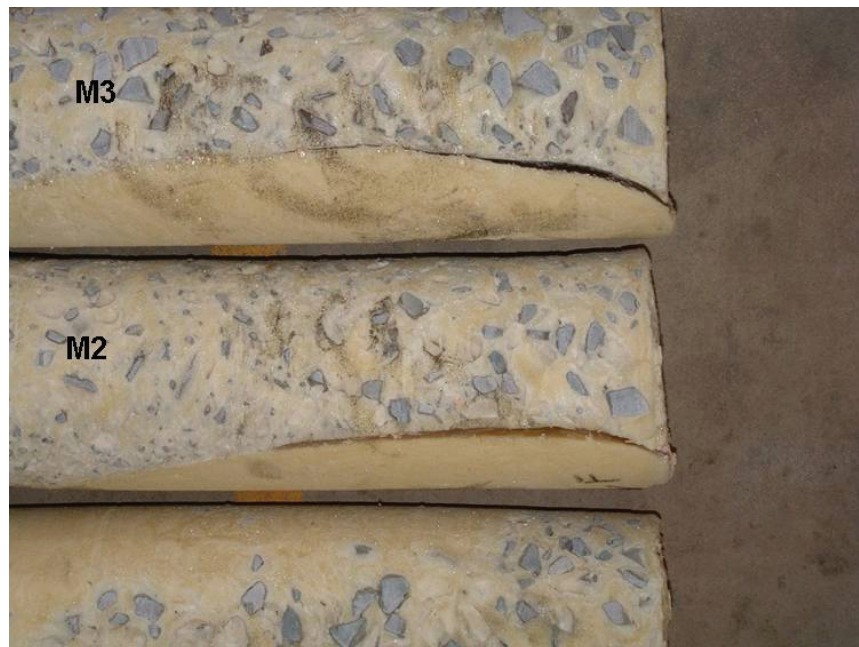
**Figure 18.—Separation along the interface between lifts observed in 6-in-diam core drilled horizontally. The right side of the cores is the front side of the seal.**

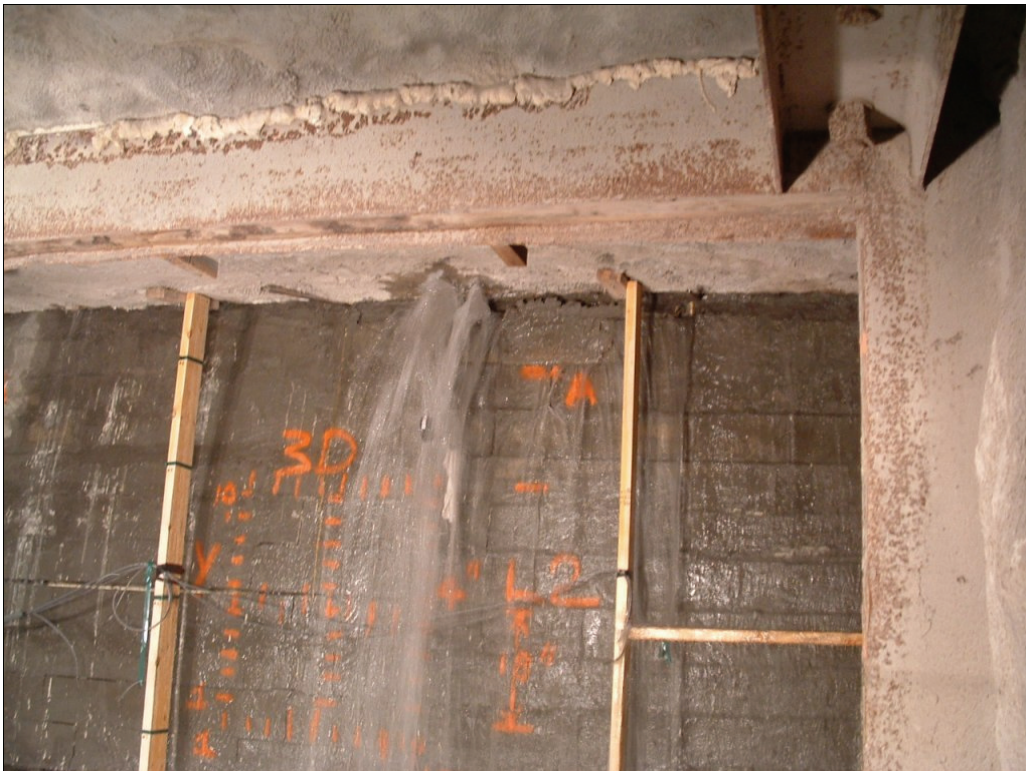
Figure 24.—Water leakage observed from failure zone along upper right side of the seal.
